HAVE YOU NOTICED HOW THE CHANCEL DOES NOT QUITE FIT THE NAVE?

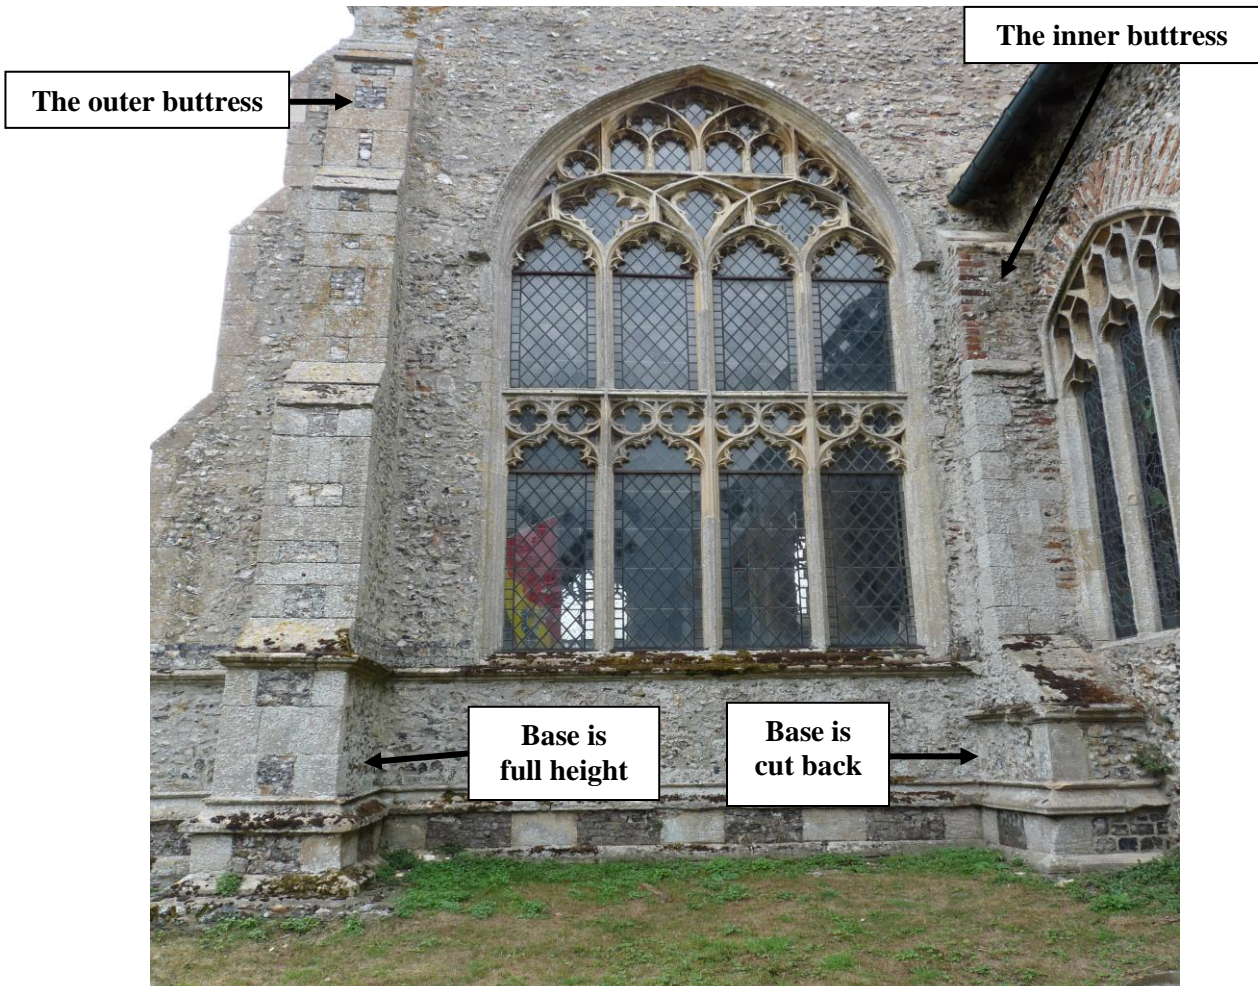
Fig.1 General view of the east end of the south aisle, showing the inner and outer buttresses

Standing in the centre aisle of the new nave you would have looked in wonder at the magnificent tracery in the aisle windows and seen in front of you the huge chancel arch which was much too big for the old chancel. There would probably have been some wood and canvas structure filling the gap to make it weathertight. High above this arch was a large east window bringing in even more light. This window would have been high above the roof of the old chancel. Externally, the east end of the nave would have been supported by the four buttresses that still exist. Fig.1 shows the end of the south aisle. The outer pair of buttresses are, of course, designed to support the aisle walls, while the inner two buttresses are aligned with the piers of the arcades.

The master mason would have been asked to devise a way of replacing the little chancel by a much larger one, and this building would of course need to have its walls buttressed. At its east end were the diagonally aligned buttresses that we see today, and at the west end he slotted the building in between the pre-existing inner pair of buttresses that supported the east wall of the nave. However, this meant that the first of the chancel windows was partially obscured by the buttress and he had to cut these buttresses back. If you look at Fig.1 you can see that the plinth of the base has been lowered and cut back. You can even see where the horizontal 'stringcourse' beneath the aisle window has been cut off where it meets the buttress, and rebuilt at a lower level. You can also see that, higher up, the depth of the buttress (i.e. the E-W dimension) has been markedly reduced.

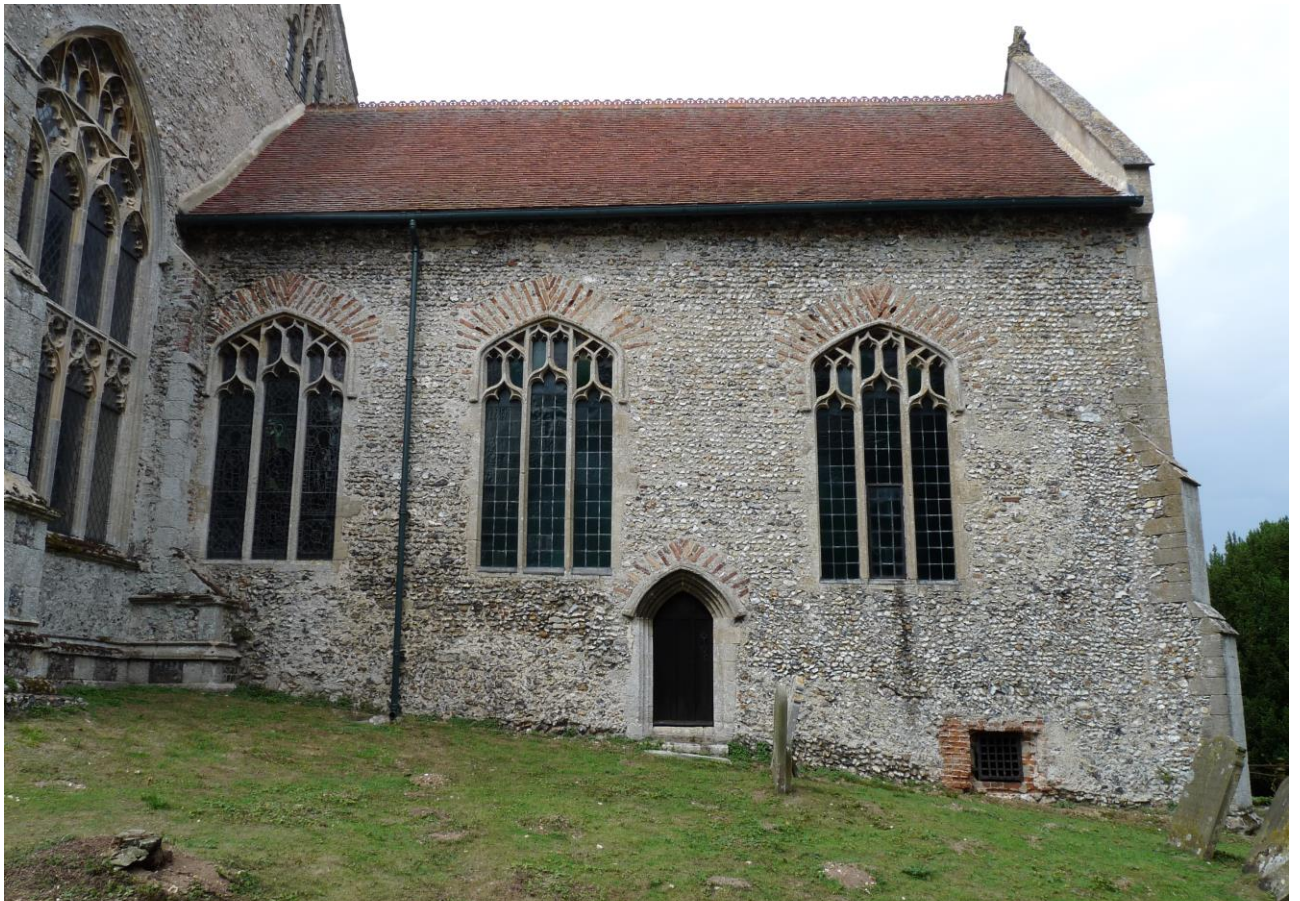
Fig.2 Note how the chancel windows are crowded towards the west (left hand) end

In Fig.2, which shows the south wall of the chancel, you can see how the windows are crowded towards the west (left hand) end of the wall. So why did the mason not introduce a short length of wall before the first window? This would have given a more balanced external appearance and avoided cutting back the buttress. The answer lies, I think, in the way in which the land falls away to the east. The small square window shows the location of the rib-vaulted crypt, which had to be built to raise-up the east end. Inserting a length of wall would have moved the whole chancel further east and this would have required an even more expensive crypt.

You can also see how the ridge of the chancel roof appears to touch the high east window. In fact it intrudes into it and the bottom part of the window tracery has been cut off and filled in. Whether this was a result of the large new chancel or the new lead roof of the nave is another story!
